**Flood Control Project Maintenance
Levee Inspections**

Fall 2011 Levee Maintenance Deficiency Summary Report

Reclamation District No. 0765 Glide

Levee Inspection Report By Mile - Fall 2011

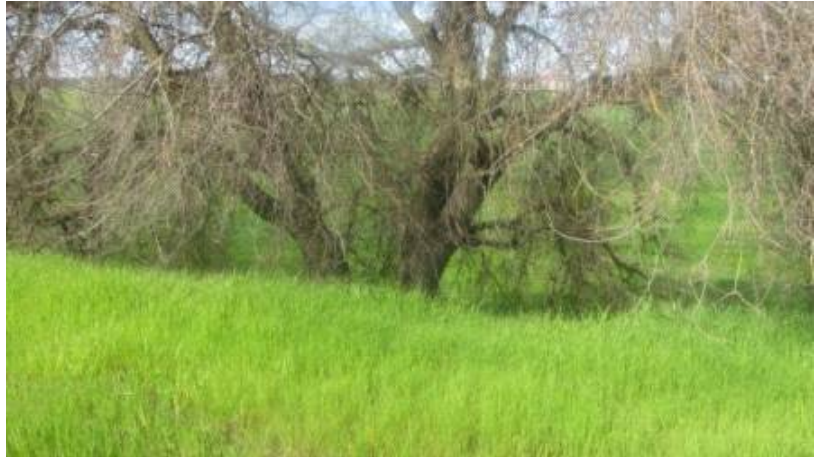
Levee Mile Report Line	3
Start Levee Mile	0.12
End Levee Mile	0.19
Location	Land Side
Category	Earthen Levee
Item	Trim / Thin Trees

Looking west at trees on landside toe.

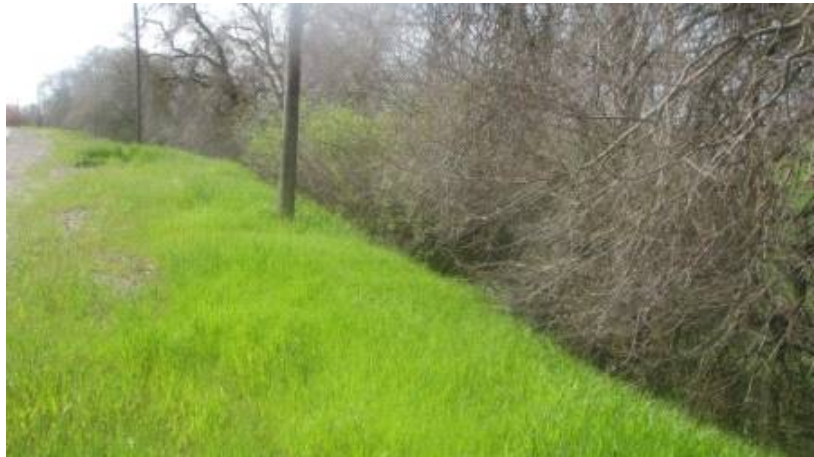
Levee Mile Report Line	3
Start Levee Mile	0.12
End Levee Mile	0.19
Location	Land Side
Category	Earthen Levee
Item	Trim / Thin Trees

Looking downstream (south) at trees on landside slope & toe.

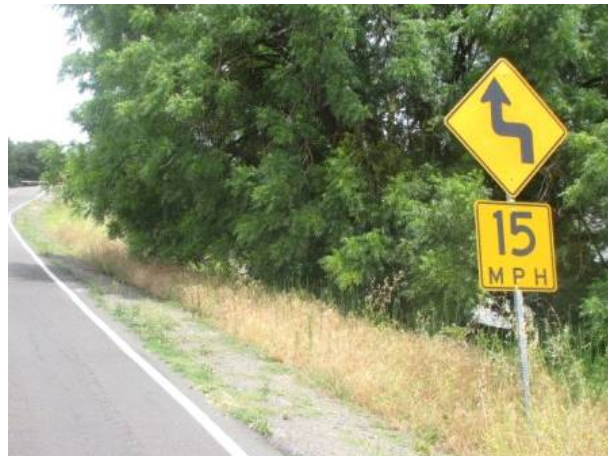
Levee Mile Report Line	6
Start Levee Mile	0.25
End Levee Mile	0.28
Location	Water Side
Category	Earthen Levee
Item	Trim / Thin Trees

Looking northeast at overgrown trees on waterside slope.

6	0.25	0.28	Earthen Levee	Trim / Thin Trees	WS	U	Thin trees to allow visibility of the ground and room to flood fight.	38.499405 ° -121.560445 °	38.499042 ° -121.560430 °	11 Y
7	0.32	0.32	Earthen Levee	Trim / Thin Trees	WS	M	Trim trees to at least five feet above ground level.	38.498453 ° -121.560360 °	38.498453 ° -121.560360 °	23
8	0.41	0.41	Earthen Levee	Trim / Thin Trees	LS	M	Trim trees to at least five feet above ground level.	38.497196 ° -121.560147 °	38.497196 ° -121.560147 °	21
9	0.41	0.52	Earthen Levee	Trim / Thin Trees	WS	M	Trim trees to at least five feet above ground level.	38.497125 ° -121.560087 °	38.495648 ° -121.559391 °	24
10	0.43	0.47	Earthen Levee	Trim / Thin Trees	LS	M	Trim and thin trees to allow visibility of the ground and room to flood fight.	38.496792 ° -121.560026 °	38.496321 ° -121.559842 °	32
11	0.48	0.50	Earthen Levee	Vegetation	LS	U	Remove the wild growth other than native grasses from the levee slopes.	38.496217 ° -121.559788 °	38.495855 ° -121.559586 °	33 Y

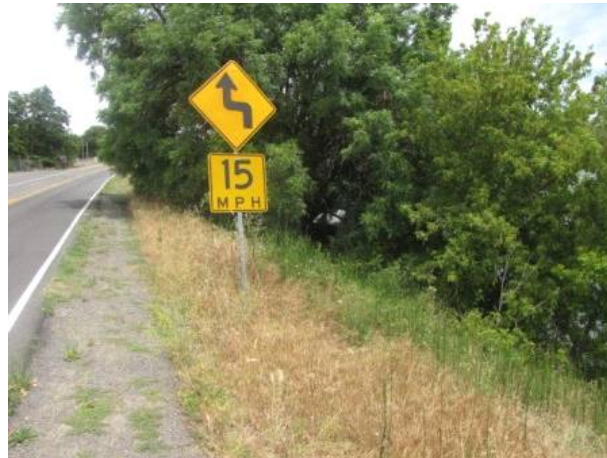
Levee Mile Report Line	6
Start Levee Mile	0.25
End Levee Mile	0.28
Location	Water Side
Category	Earthen Levee
Item	Trim / Thin Trees
Looking north at dense trees on waterside slope from fall 2010 inspection.	
richard_f_20111014_888.jpg

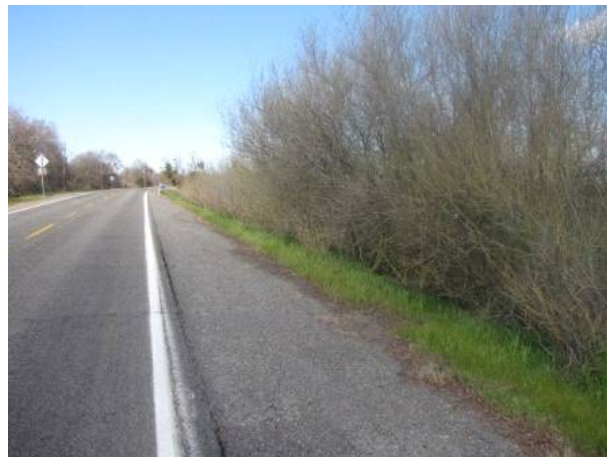
Levee Mile Report Line	6
Start Levee Mile	0.25
End Levee Mile	0.28
Location	Water Side
Category	Earthen Levee
Item	Trim / Thin Trees
Looking upstream (north) at dense vegetation and trees from 2011 spring inspection.	
richard_f_20111014_889.jpg

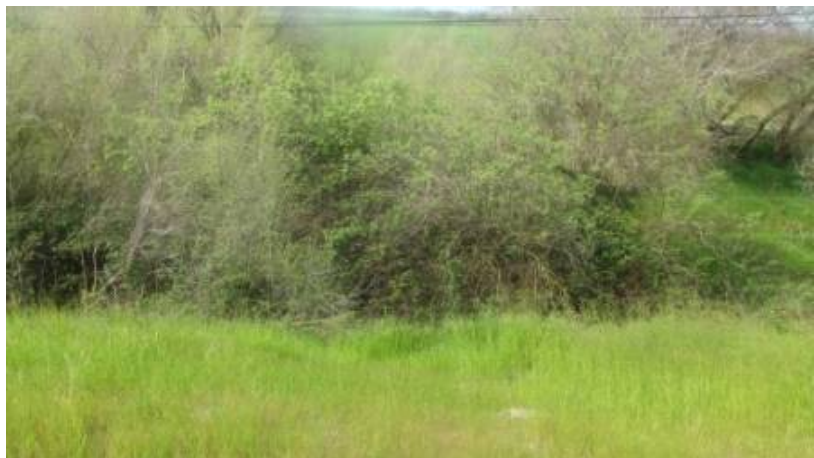
Levee Mile Report Line	11
Start Levee Mile	0.48
End Levee Mile	0.50
Location	Land Side
Category	Earthen Levee
Item	Vegetation
Looking northwest at trees on landside toe from 2010 fall inspection.	
richard_f_20111014_899.jpg

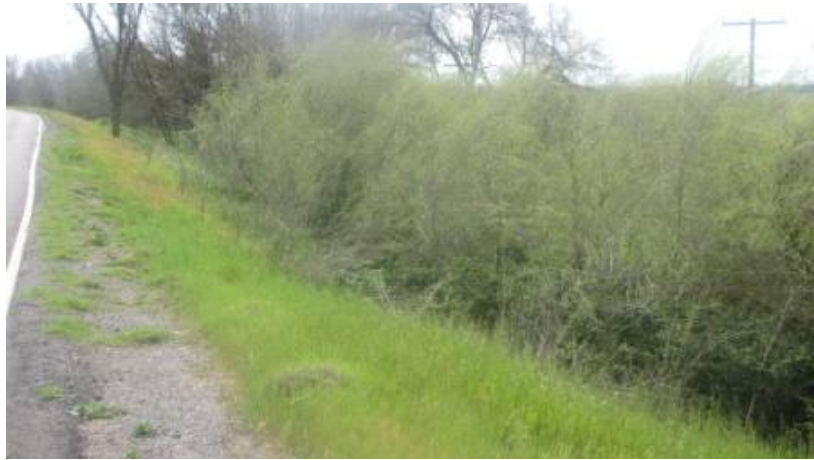
Levee Mile Report Line	11
Start Levee Mile	0.48
End Levee Mile	0.50
Location	Land Side
Category	Earthen Levee
Item	Vegetation

Looking downstream (south) at trees on landside slope & toe.

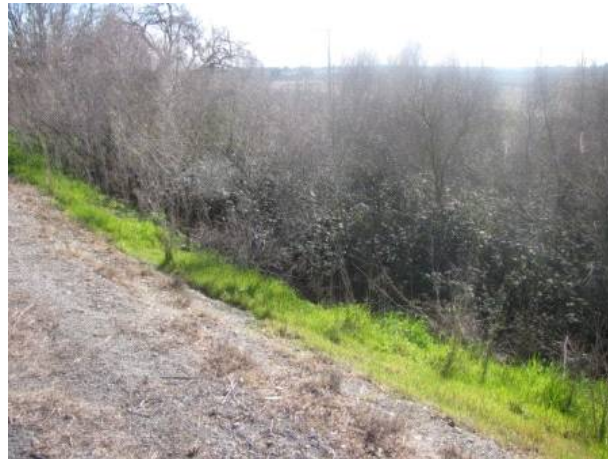
Levee Mile Report Line	11
Start Levee Mile	0.48
End Levee Mile	0.50
Location	Land Side
Category	Earthen Levee
Item	Vegetation

Looking downstream (southwest) at dense vegetation on landside slope.

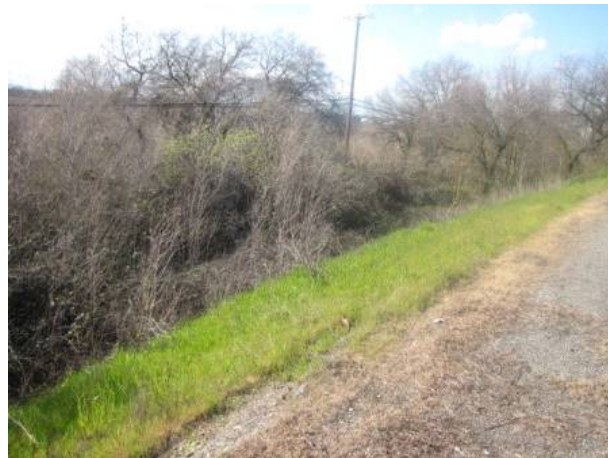
Levee Mile Report Line	11
Start Levee Mile	0.48
End Levee Mile	0.50
Location	Land Side
Category	Earthen Levee
Item	Vegetation

Looking upstream (northwest) at dense vegetation on landside slope.

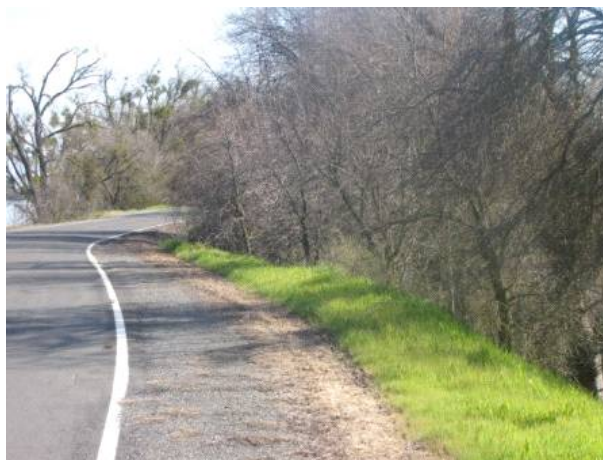
Levee Mile Report Line	20
Start Levee Mile	0.87
End Levee Mile	1.03
Location	Land Side
Category	Earthen Levee
Item	Trim / Thin Trees

Looking downstream (south) at dense trees on landside slope and toe.

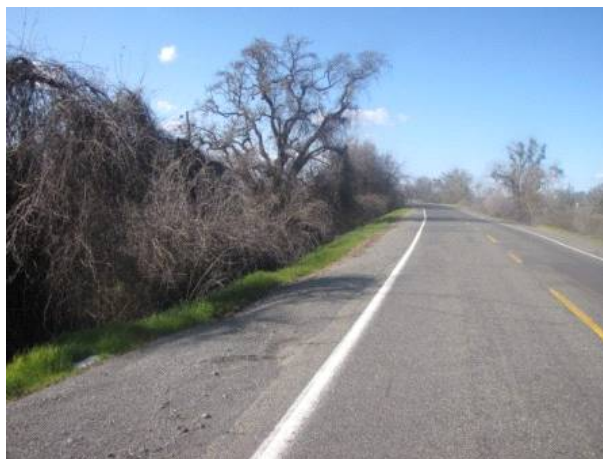
Levee Mile Report Line	20
Start Levee Mile	0.87
End Levee Mile	1.03
Location	Land Side
Category	Earthen Levee
Item	Trim / Thin Trees

Looking upstream (north) at dense trees on landside slope and toe.

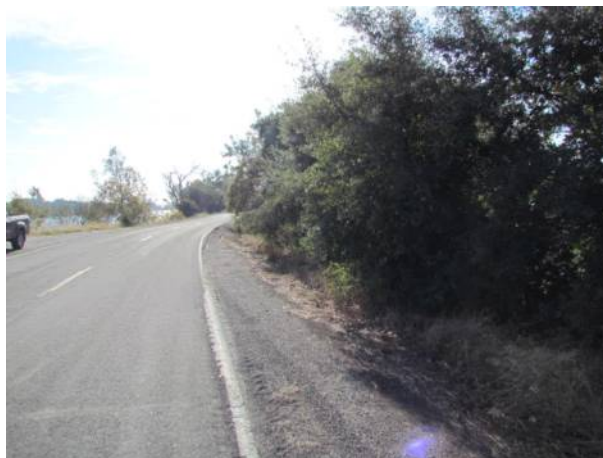
Levee Mile Report Line	20
Start Levee Mile	0.87
End Levee Mile	1.03
Location	Land Side
Category	Earthen Levee
Item	Trim / Thin Trees

Looking south at dense trees on landside shoulder and slope. (November 2011)

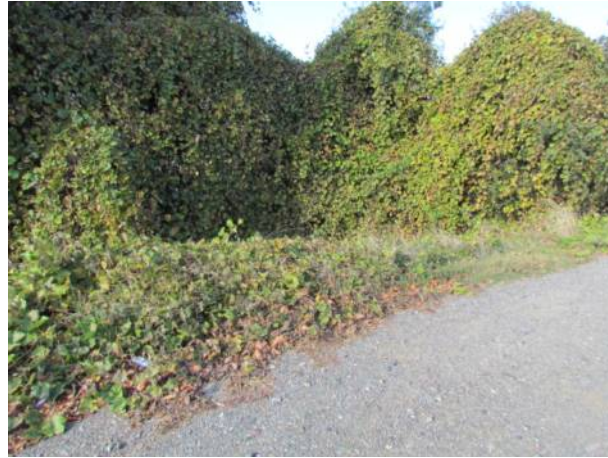
Levee Mile Report Line	21
Start Levee Mile	0.97
End Levee Mile	0.97
Location	Land Side
Category	Earthen Levee
Item	Vegetation

Looking west at dense berryvines and wildroses on landside shoulder and slope. (November 2011)

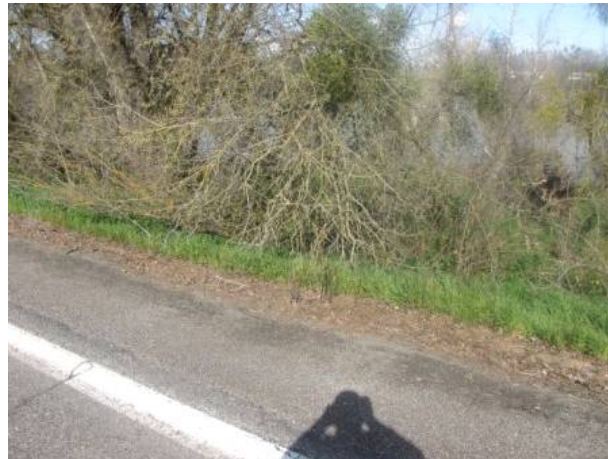
Levee Mile Report Line	22
Start Levee Mile	0.99
End Levee Mile	1.05
Location	Water Side
Category	Earthen Levee
Item	Trim / Thin Trees

Looking upstream (northeast) at dense vegetation on waterside slope.

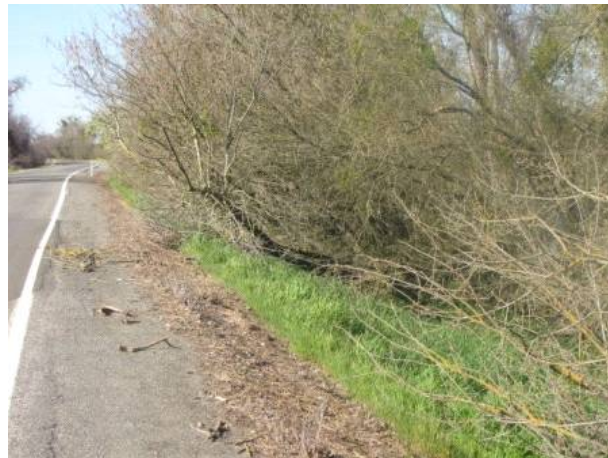
Levee Mile Report Line	22
Start Levee Mile	0.99
End Levee Mile	1.05
Location	Water Side
Category	Earthen Levee
Item	Trim / Thin Trees

Looking upstream (north) dense vegetation and trees on waterside shoulder and slope.

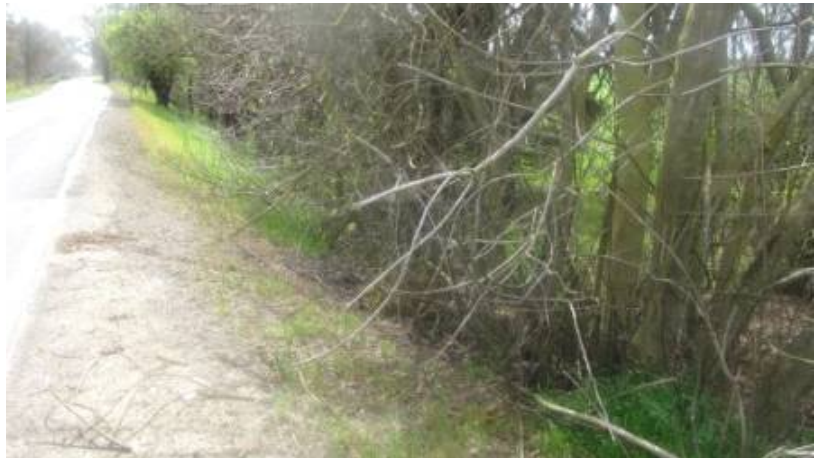
Levee Mile Report Line	23
Start Levee Mile	1.08
End Levee Mile	1.08
Location	Land Side
Category	Earthen Levee
Item	Trim / Thin Trees

Looking downstream (south) at trees on landside slope & toe from 2010 fall inspection.

23	1.08	1.08	Earthen Levee	Trim / Thin Trees	LS	U	Trim and thin trees to allow visibility of the ground and room to flood fight.	38.488503 ° -121.554757 °	38.488503 ° -121.554757 °	37 Y
24	1.10	1.16	Earthen Levee	Trim / Thin Trees	LS	M	Trim trees to at least five feet above ground level.	38.488279 ° -121.554615 °	38.487465 ° -121.554117 °	38 Y
25	1.15	1.15	Earthen Levee	Vegetation	LS	M	Remove the wild growth other than native grasses from the levee slopes.	38.487653 ° -121.554248 °	38.487653 ° -121.554248 °	39 Y
26	1.16	1.16	Earthen Levee	Trim / Thin Trees	WS	M	Trim trees to at least five feet above ground level.	38.487473 ° -121.554080 °	38.487473 ° -121.554080 °	9 Y
27	1.19	1.22	Earthen Levee	Encroachments	LS	CO	Buildings	38.487127 ° -121.553910 °	38.486702 ° -121.553652 °	43 Y
28	1.32	1.32	Earthen Levee	Trim / Thin Trees	LS	M	Trim trees to at least five feet above ground level.	38.485280 ° -121.552860 °	38.485280 ° -121.552860 °	26 Y

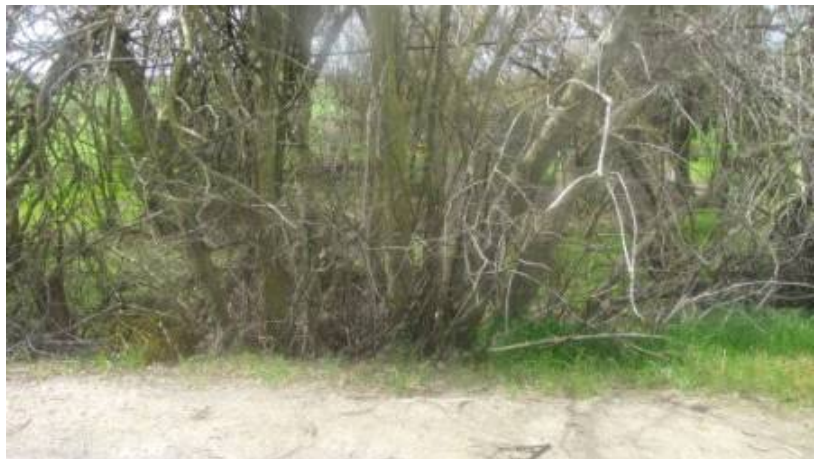
Levee Mile Report Line	23
Start Levee Mile	1.08
End Levee Mile	1.08
Location	Land Side
Category	Earthen Levee
Item	Trim / Thin Trees

Looking west at trees on landside slope & toe.

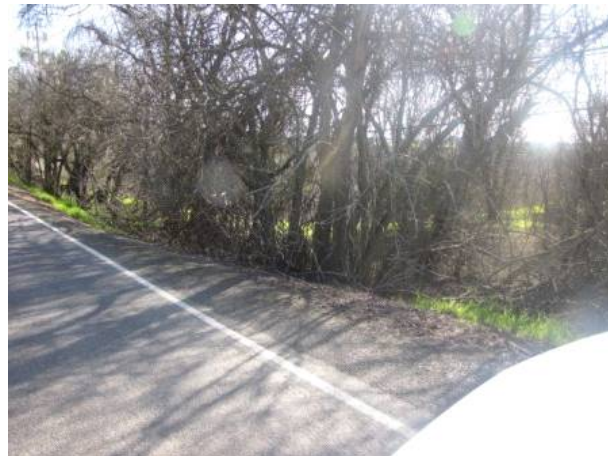
Levee Mile Report Line	23
Start Levee Mile	1.08
End Levee Mile	1.08
Location	Land Side
Category	Earthen Levee
Item	Trim / Thin Trees

Looking downstream (southwest) at dense trees on landside slope and toe.

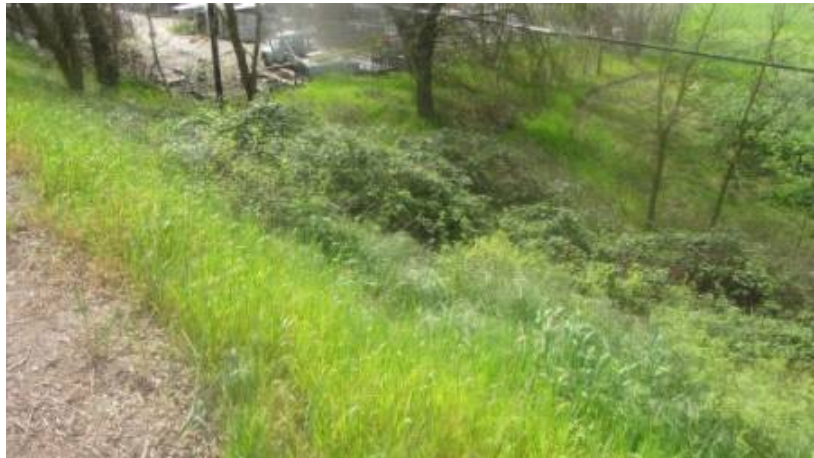
Levee Mile Report Line	25
Start Levee Mile	1.15
End Levee Mile	1.15
Location	Land Side
Category	Earthen Levee
Item	Vegetation

Looking downstream (southwest) at wild roses on landside slope & toe.

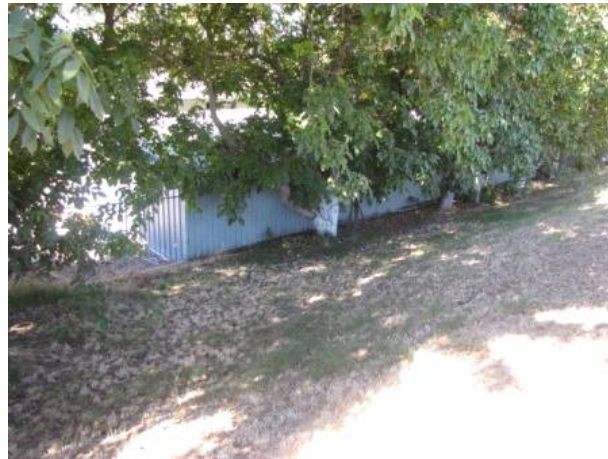
Levee Mile Report Line	27
Start Levee Mile	1.19
End Levee Mile	1.22
Location	Land Side
Category	Earthen Levee
Item	Encroachments

Looking northwest at buildings along landside toe.

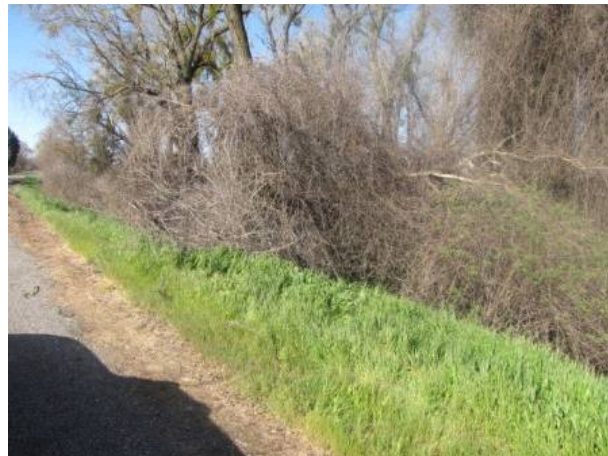
Levee Mile Report Line	29
Start Levee Mile	1.36
End Levee Mile	1.36
Location	Water Side
Category	Earthen Levee
Item	Trim / Thin Trees

Looking upstream (north) at dense vegetation on waterside slope.

29	1.36	1.36	Earthen Levee	Trim / Thin Trees	WS	U	Trim trees to at least five feet above ground level.	38.484877 ° -121.552540 °	38.484877 ° -121.552540 °	7 Y
30	1.41	1.41	Earthen Levee	Trim / Thin Trees	WS	M	Trim trees to at least five feet above ground level.	38.484316 ° -121.552115 °	38.484316 ° -121.552115 °	4 Y
31	1.44	1.47	Earthen Levee	Trim / Thin Trees	WS	M	Thin trees to allow visibility of the ground and room to flood fight.	38.483925 ° -121.551845 °	38.483530 ° -121.551587 °	5 Y
32	1.50	1.50	Earthen Levee	Trim / Thin Trees	LS	M	Trim trees to at least five feet above ground level.	38.483170 ° -121.551367 °	38.483170 ° -121.551367 °	42 Y
33	1.54	1.54	Earthen Levee	Vegetation	LS	U	Remove the wild growth other than native grasses from the levee slopes.	38.482590 ° -121.551020 °	38.482590 ° -121.551020 °	29 Y
34	1.60	1.67	Earthen Levee	Trim / Thin Trees	WS	M	Trim trees to at least five feet above ground level.	38.480913 ° -121.549677 °	38.480993 ° -121.549738 °	2 Y

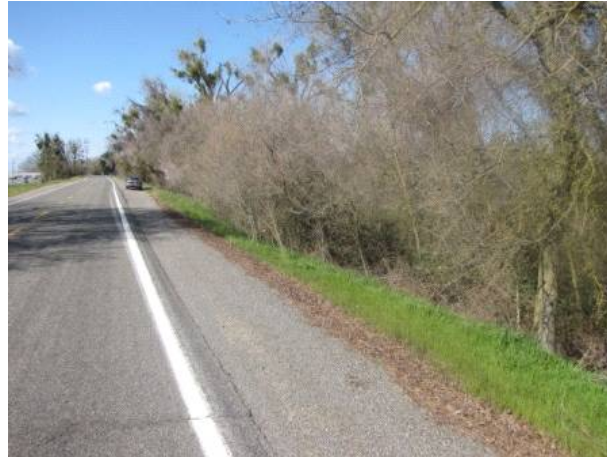
Levee Mile Report Line	31
Start Levee Mile	1.44
End Levee Mile	1.47
Location	Water Side
Category	Earthen Levee
Item	Trim / Thin Trees

Looking upstream (north) at dense trees on waterside slope.

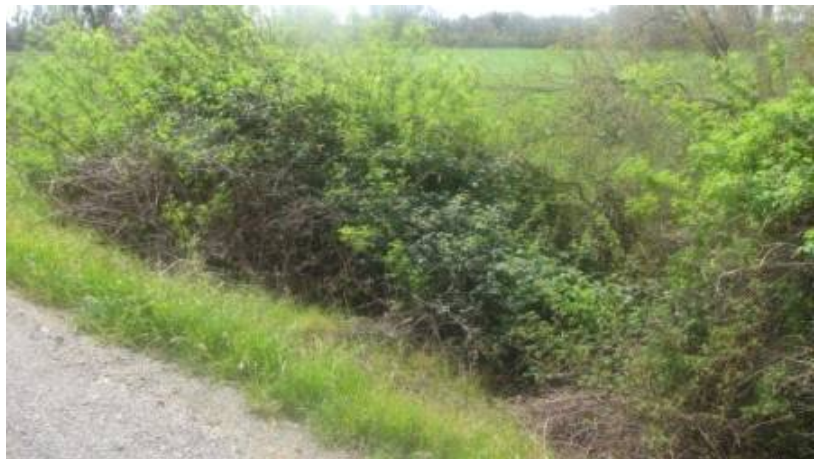
Levee Mile Report Line	33
Start Levee Mile	1.54
End Levee Mile	1.54
Location	Land Side
Category	Earthen Levee
Item	Vegetation

Looking downstream (southwest) at trees, vines & wildroses on landside slope & toe from 2010 fall inspection

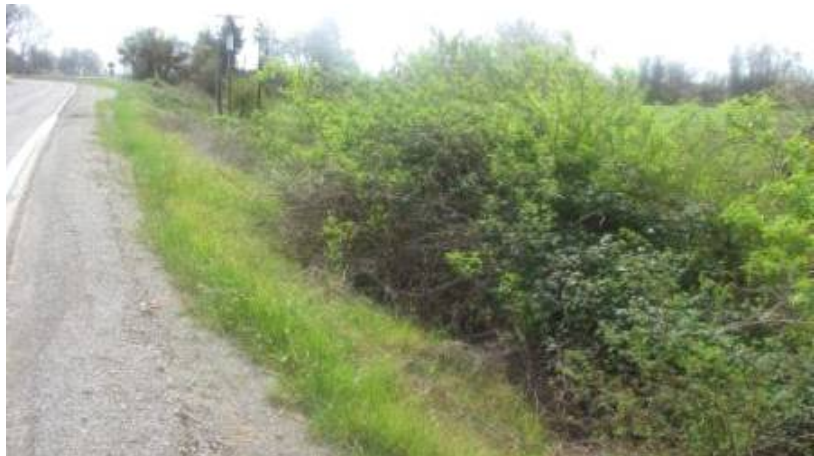
Levee Mile Report Line	33
Start Levee Mile	1.54
End Levee Mile	1.54
Location	Land Side
Category	Earthen Levee
Item	Vegetation

Looking downstream (south) at trees, vines & wildroses on landside slope & toe.

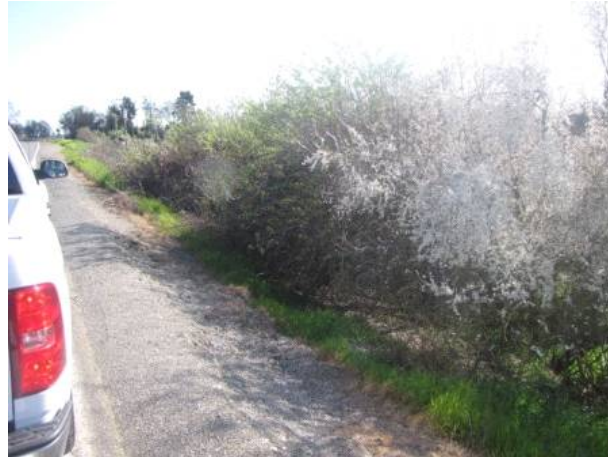
Levee Mile Report Line	33
Start Levee Mile	1.54
End Levee Mile	1.54
Location	Land Side
Category	Earthen Levee
Item	Vegetation

Looking downstream (south) at dense vegetation on landside slope and toe.

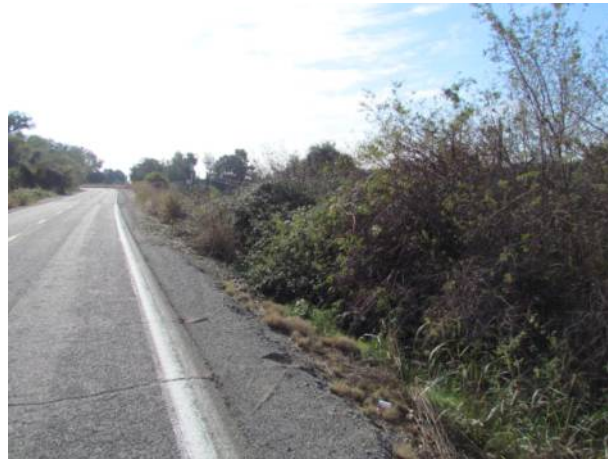
Levee Mile Report Line	33
Start Levee Mile	1.54
End Levee Mile	1.54
Location	Land Side
Category	Earthen Levee
Item	Vegetation

Looking south at dense vegetation on landside shoulder and slope. (November 2011)

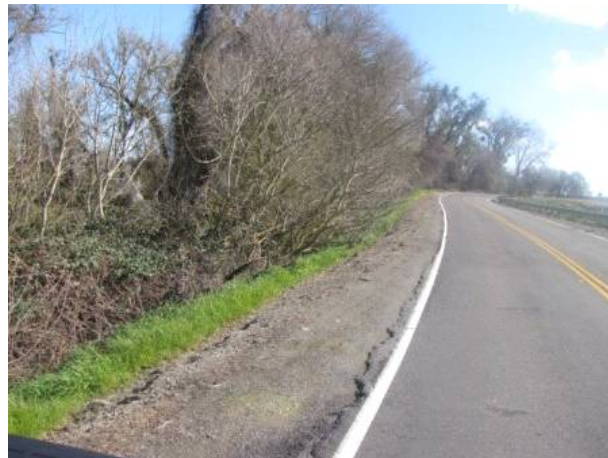
Levee Mile Report Line	34
Start Levee Mile	1.60
End Levee Mile	1.67
Location	Water Side
Category	Earthen Levee
Item	Trim / Thin Trees

Looking south at dense trees on waterside slope.

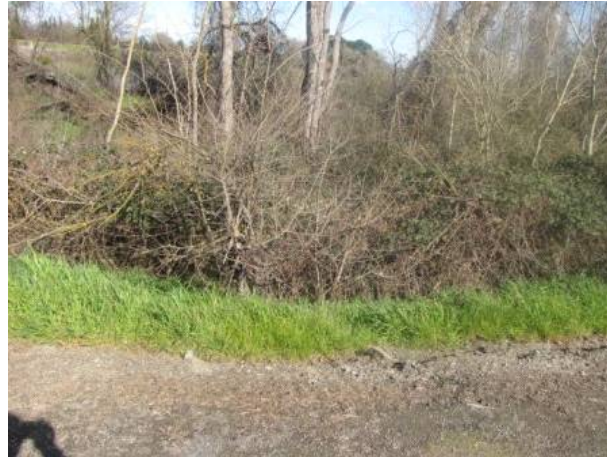
Levee Mile Report Line	34
Start Levee Mile	1.60
End Levee Mile	1.67
Location	Water Side
Category	Earthen Levee
Item	Trim / Thin Trees

Looking east at dense vegetation on waterside slope.

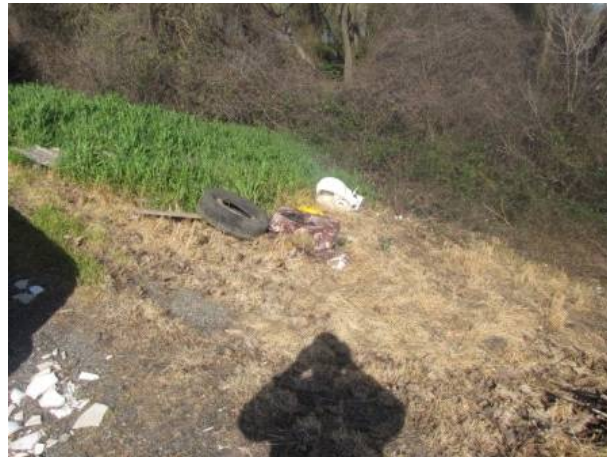
Levee Mile Report Line	36
Start Levee Mile	1.69
End Levee Mile	1.69
Location	Water Side
Category	Earthen Levee
Item	Encroachments

LMR No.	Levee Mile		Category	Item	* Location	** Rating	Action/Comment	GPS Latitude/Longitude		Issue No.
	Start	End						Start	End	Photo
36	1.69	1.69	Earthen Levee	Encroachments	WS	M	Garbage Inspector Comments: Garbage and pruning pile on waterside shoulder.	38.480770 ° -121.549514 °	38.480895 ° -121.549556 °	30 Y
37	1.70	1.70	Earthen Levee	Encroachments	WS	W	Prunings	38.480632 ° -121.549543 °	38.480632 ° -121.549543 °	13 Y
38	1.70	1.73	Earthen Levee	Trim / Thin Trees	WS	M	Trim trees to at least five feet above ground level.	38.480602 ° -121.549523 °	38.480257 ° -121.549458 °	1 Y

Looking northeast at garbage on waterside slope. (May 2011)

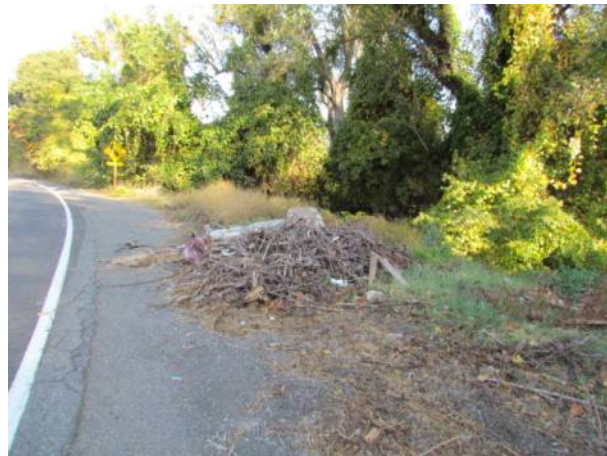
Levee Mile Report Line	36
Start Levee Mile	1.69
End Levee Mile	1.69
Location	Water Side
Category	Earthen Levee
Item	Encroachments

Looking north at garbage and pruning pile on waterside shoulder. (November 2011)

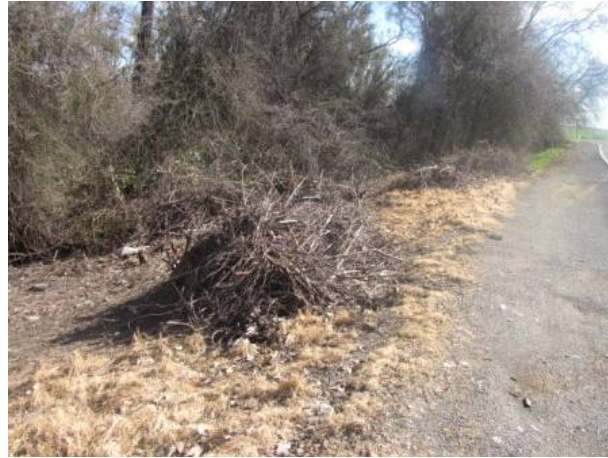
Levee Mile Report Line	37
Start Levee Mile	1.70
End Levee Mile	1.70
Location	Water Side
Category	Earthen Levee
Item	Encroachments

Looking southeast at pruning piles on waterside shoulder & slope.

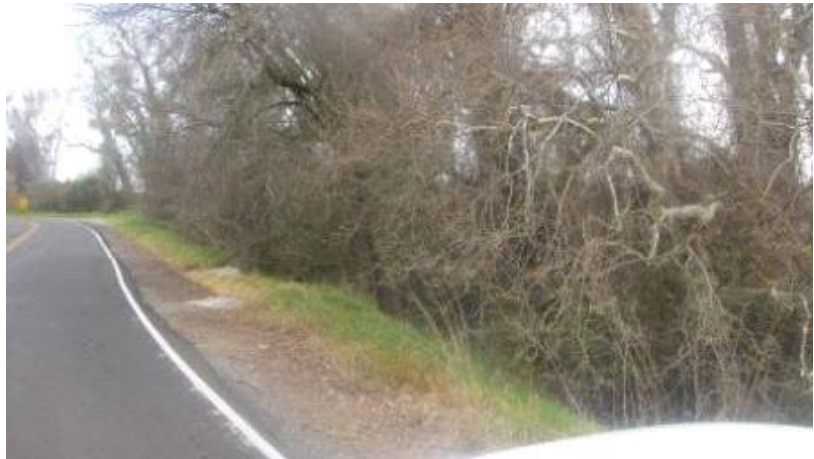
Levee Mile Report Line	38
Start Levee Mile	1.70
End Levee Mile	1.73
Location	Water Side
Category	Earthen Levee
Item	Trim / Thin Trees

Looking upstream (north) at trees on waterside slope.

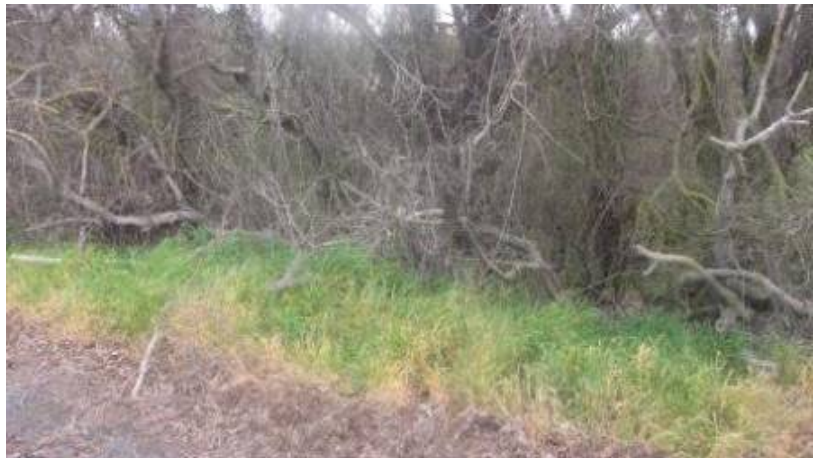
Levee Mile Report Line	38
Start Levee Mile	1.70
End Levee Mile	1.73
Location	Water Side
Category	Earthen Levee
Item	Trim / Thin Trees

Looking east at trees on waterside slope.

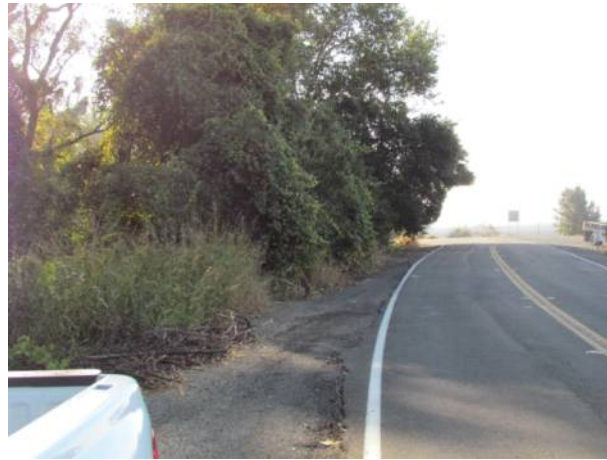
Levee Mile Report Line	38
Start Levee Mile	1.70
End Levee Mile	1.73
Location	Water Side
Category	Earthen Levee
Item	Trim / Thin Trees

Looking south at dense trees and vegetation on waterside slope. (November 2011)
